Building Assessment – River Ridge School District - Bloomington Middle School

Introduction ADG and its Consultant – Ring & DuChateau – conducted and documented site observations on at least two occasions the result of this information gathering effort is outlined below. No destructive tests were performed; therefore, all information gathered was visually and/or verbally gathered.

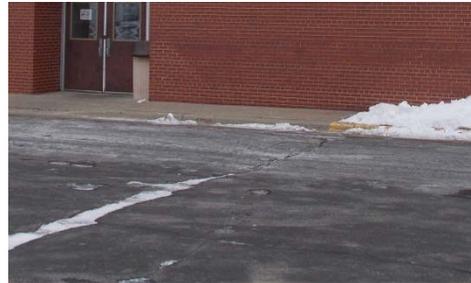
A. Parking lot: Consists of asphalt paving and most areas are in good condition. Many areas that have cracked over its life-time have been patched or filled and it appears that regular maintenance has occurred. There are areas/locations that required routine maintenance to preserve its integrity, most noted at the drive through areas southwest corner.

Recommendations: At areas of cracking in the asphalt paving, consideration should be given to clearing debris and previous prevention methods within the existing cracks. The cracks should then be sealed with appropriate asphaltic crack filler and the entire parking lot resealed and striped. At the southwest corner at drive-thru, consideration should be given to removing an asphalt area, re-compacting the subgrade and new asphalt installed.

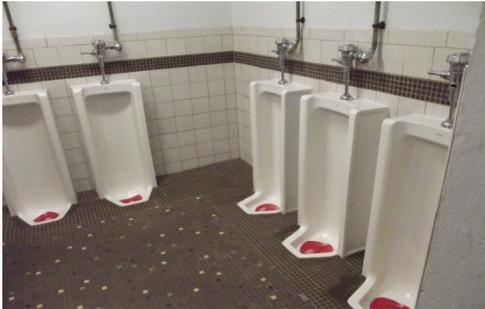
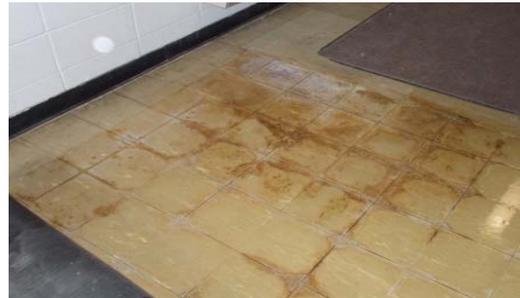
A. Flooring: Substrate (subfloor) is slab-on-grade/cast in place concrete. There is little to no evidence of cracking or settling and is in generally good condition. There is evidence of excessive moisture present under the slab at the corridor exiting near the Shop area. It is undeterminable, without taking potentially destructive measures, to establish the source of the moisture. Also, in discussion with Dan Hermson – a Contractor who installed new urinals in the summer of 2012, I have learned that the traps associated with the original three urinals were corroded, deteriorated and leaking. He indicated that the renovation consisted of removal of the saturated fill and installation of new plumbing infrastructure, new fill material, new urinals and new finished concrete floor inclusive of new tile. He could not determine the extent or the amount sanitation water that escaped due to the defective plumbing components – but did indicate he routinely made trips to the school since the 1970's to unclog the plumbing lines associated with these specific urinals.

Recommendation: Core drilling of the concrete slab in the toilet room associated with the urinal replacement and in the corridor where evidence of moisture is present should be conducted to determine the extent – if any – of sanitation water and/or other water related problems exist under the slab in this facility. Once determined corrective measures – if required – should be determined and performed.

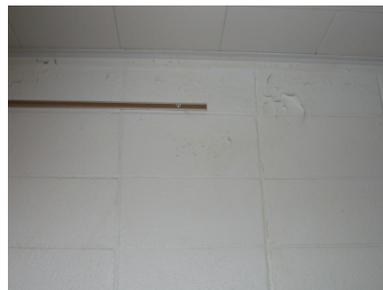
G. Walls: In most areas of the facility the interior and exterior walls consist of painted (PNT), stack bond, concrete masonry units (CMU). Shower room walls consist of ceramic glazed CMU. Structurally, no areas of excessive cracking or settling of walls is apparent and all appear structurally sound. Areas of blistered paint are evident in the corridor; this condition appears to be moisture related and substantially limited to the corridor nearest the interior ramp.

Recommendation: Areas of damaged CMU – most noted in a small area in the Gymnasium – should be corrected. It must be determined if the moisture related

problem in the corridor is an “on-going” situation or if it was present prior to the installation of the new steel roofing system; and corrective measures taken accordingly. In any renovation project, the existing CMU walls would be cleaned and repainted.

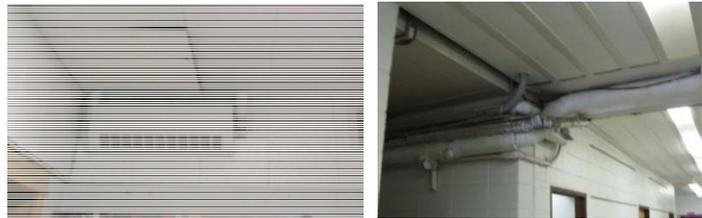
I. Finished Ceilings: In most areas of the facility, the finish ceiling consists of a suspended type of tile with integral lighting original to the date of construction. Investigation should occur to determine if the existing tile contains asbestos. The ceiling tile in the Music Classroom Office is falling down. Areas of exposed piping are present in the corridors.

Recommendation: The existing ceiling system has reached its life expectancy and consideration should be given to its replacement with a new suspended system complete with updated lighting. Areas of exposed structure should be repainted as a part of any renovation project.

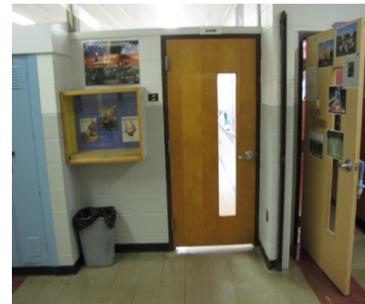
J. Interior Doors: The existing interior doors typically are wood and are provided with the appropriate handicap accessible hardware. Generally, these units are in good condition with some units showing signs of heavy to excessive wear. The frame height is 80”, which allows for a door height of 78” – today’s code requires door heights – in commercial applications – to be 80”. At some classroom locations the proper A.D.A. handicap clearance at the latch side of the door of 18” does not exist.

Recommendation: As a component of any renovation project, consideration should be given to the replacement of heavily worn units and the refinishing of all existing doors. Consideration could also be given to changing the swing direction of the non-A.D.A. compliant units.

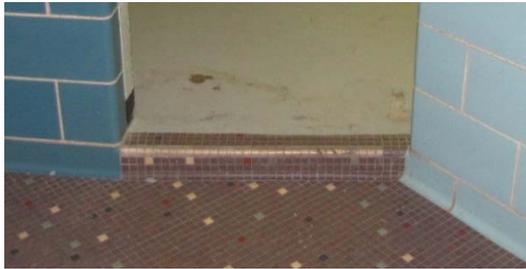
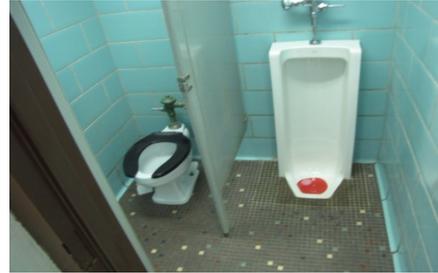
L. American with Disabilities Act – A.D.A.: Currently, none of the Toilet Rooms meet today's size standards for handicap accessibility. The Showers in the men's and women's Locker Rooms are non-compliant due to the 4" curb at entrance. The bleachers are original to the building and do not meet present day code standards for accessibility. The Stage is not handicap accessible.

Recommendation: If extensive renovations are pursued, the design should consist of making all areas of the facility handicap accessible.

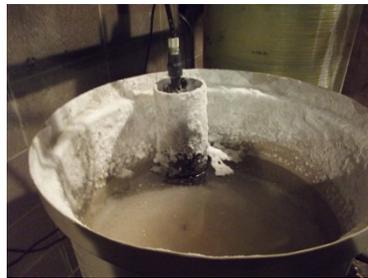
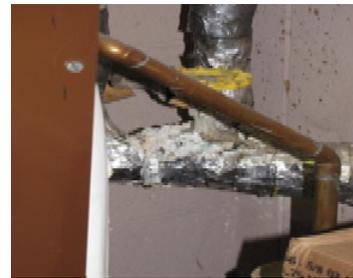
2. Water Softener: Is in poor operating condition and in need of replacement.

However, mineral deposits are apparent on various shower heads and faucets. This could be due to the poor operating condition of the water softener.
