Building Assessment – River Ridge School District – Patch Grove Elementary/High School

Introduction ADG and its Consultant – Ring & DuChateau – conducted and documented site observations on at least two occasions the result of this information gathering effort is outlined below. No destructive tests were performed; therefore, all information gathered was visually and/or verbally gathered.

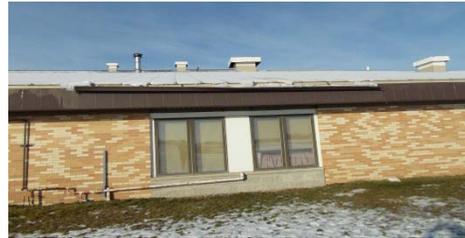
E. Windows: There are a variety of window types throughout the facility – with vinyl windows located in the cafeteria area, metal clad wood units in the elementary wing and the 2001 addition and aluminum units located – typically – in the original high school building. All units are in reasonably good condition; however, they do not meet today's standards for energy efficiency.

Recommendation: If additions/renovations are pursued, consideration should be given to replacing the window units with energy efficient models which meet today's energy standards. **P-2 \$154,000**

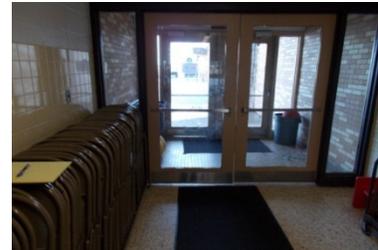
F. Exterior Doors: Like the windows, various types of exterior doors are found throughout the facility – this is mainly a condition of the dates of additions. In general, all units are in good condition, however, many lack adequate weather-stripping, are equipped with single pane glazing and again, like the windows, do not meet today's standards for energy efficiency.

Recommendation: If additions/renovations are pursued, consideration should be given to replacing the door units with energy efficient models which meet today's energy standards. **P-2 \$150,000**

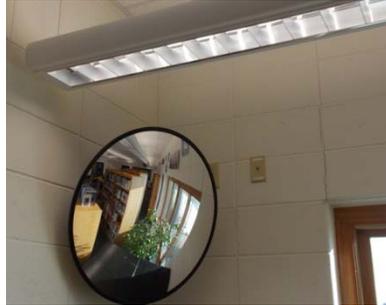
3. In the 2001 addition, in the IMC, there are areas of cracked CMU walls – most noted in the southwest corner and by the door common with the MAC Lab.

1. Expansion joints at tile should be caulked and damaged tile replaced. **O&M \$500**
2. Consideration should be given to repairing/replacing tile in Men’s Locker Room. **P-1 Refer to A.D.A. Below**
3. At the IMC in the 2001 addition – the cracks should be monitored to ensure they are not still “moving”. If stable, the cracks should be cleaned and caulked. If movement is still occurring, additional structural investigation should occur and repairs made accordingly. **P-1 To be Determined (TBD)**

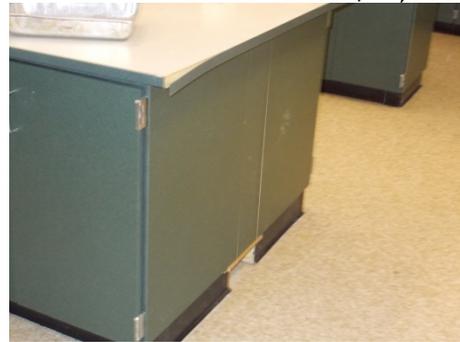
I. Casework: In classrooms containing casework much of this casework is original to the building and much of this casework exceeds current code height of 34". Casework in the most recent addition is in good condition; elementary casework, where it exists, is in fair to good condition; and casework in the high school varies in condition from new, to replaced, to original. All casework is in fair to good condition – with some limited areas in poor condition.

Recommendation: As a component of room by room renovation, consideration should be given to replacing casework with new casework which meets current code requirements. This process is already being completed in the Science Classrooms. **P-2 Allowance \$8,000/Room**

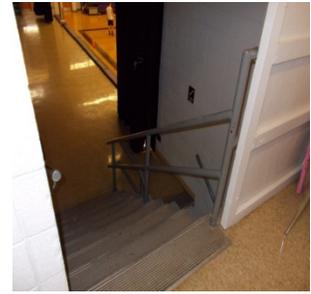
1. At the stairs leading to the second level classrooms. Current code requires that a sphere not greater than 4" in diameter can pass thru any area of a stair guard rail. **Refer to A.D.A. Allowance**
2. Shelving in the dry food storage area is wood – current code requires open stainless steel shelves.

P-1 \$2,000
