**INDOOR AIR QUALITY ASSESSMENT REPORT
FOR
RIVER RIDGE SCHOOL DISTRICT**

**11165 COUNTY HIGHWAY P
PATCH GROVE, WI 53817
FEBRUARY 21 AND 22, 2013**

**PROJECT No. RR1301
MARCH 15, 2013**

**PREPARED BY:
THOMAS L. KAPFER, CIH
PRINCIPAL
ST. CROIX ENVIRONMENTAL & SAFETY, LLC**

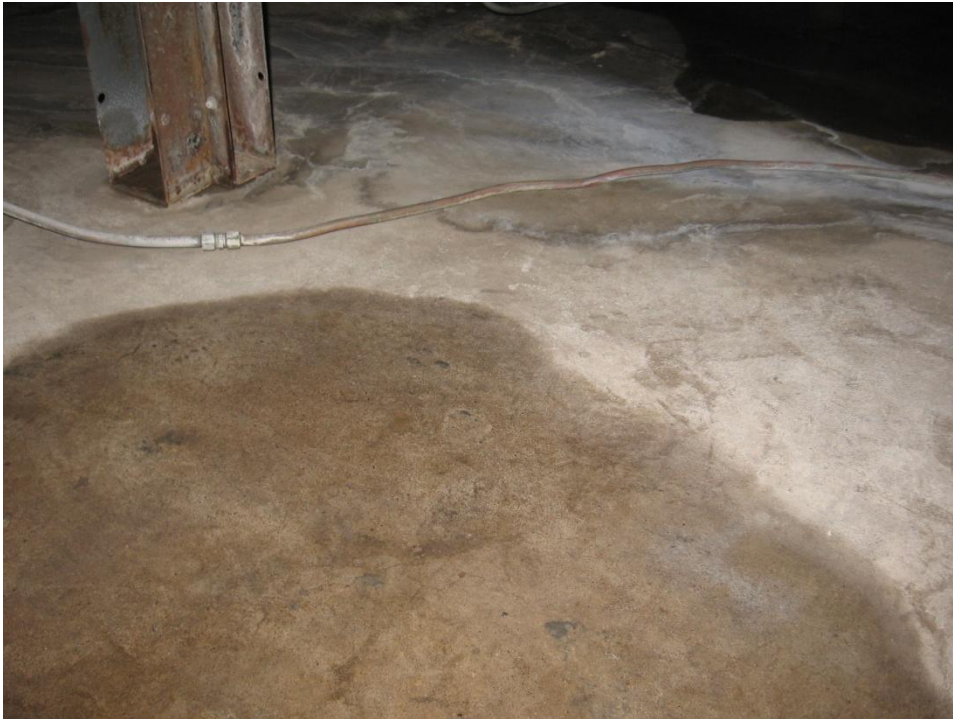
- Areas of moisture were observed on the floor of the plenum (see *Photo 2*). The source of the moisture appeared to be from the humidification nozzles located inside the plenum (see *Photo 3*). Humidification did not appear well controlled, which is the likely cause of the excess moisture inside the plenum. Excess moisture in the plenum could lead to fungal growth.

Photo 2: Areas of Moisture and Moisture Staining on Floor of Plenum

- a. To remove the fungal growth, the insulation should be removed and extensive cleaning of the entire HVAC system including air supply tunnels performed.
- b. Further assessment of the humidification system and outdoor air intake should be performed.
- c. A study of HVAC operation and temperature control should be performed to determine if adjustments or relatively minor repairs can improve temperature control.

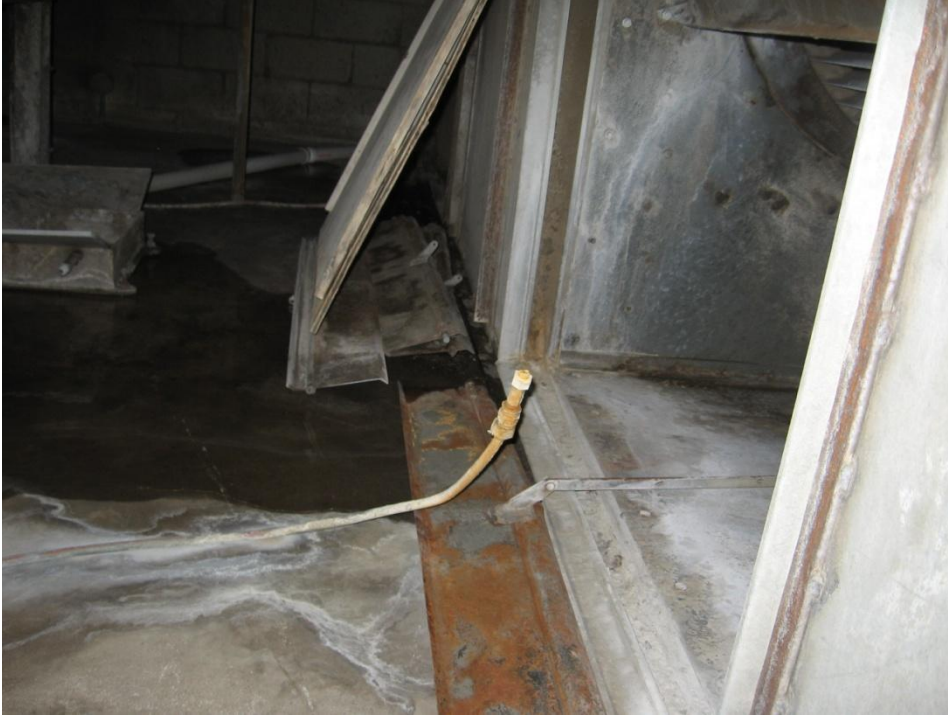
Photo 3: Spray Nozzle used to Humidify Air – Note Water on Plenum Floor in Background

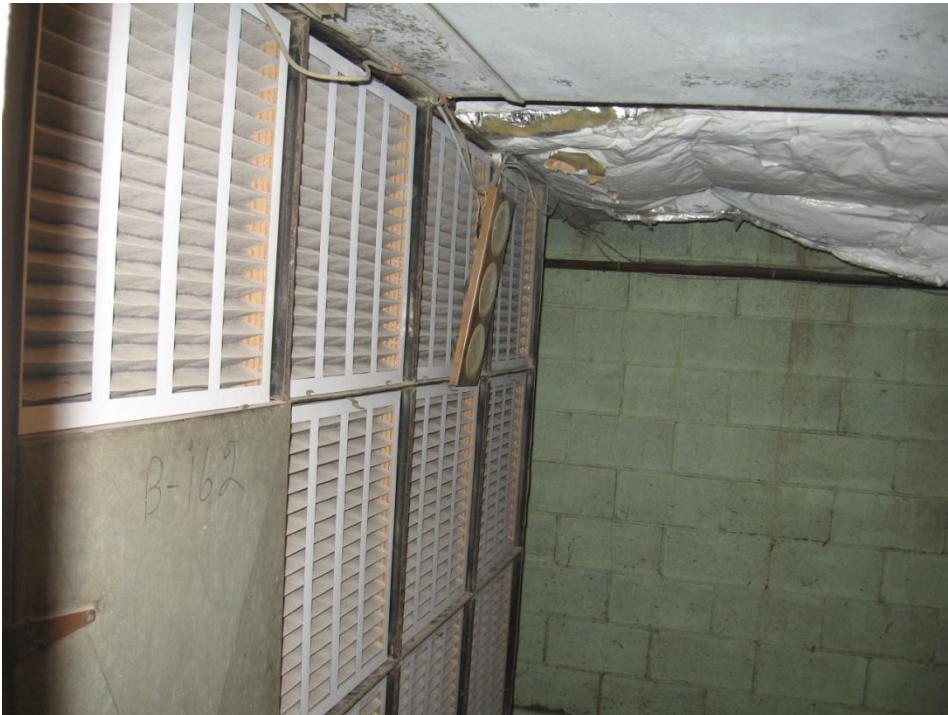
- Fiberglass insulation was observed on ductwork that conveyed air to and from the tunnel system in the return air compartment. The insulation appeared to be in poor condition and discolored (see *Photo 4*). To determine if significant fungal growth had occurred in the insulation, a bulk sample of the insulation (sample # RR1301-13) was collected and submitted for fungal analysis.

A high fungal count of 36,000,000 counts/gram was detected in the sample. The dominant fungal organisms were *Cladosporium* and *Aspergillus/Penicillium*-like. A large amount of hyphal fragments were also found in the sample. The sample result reveals heavy fungal growth in the insulation.

Photo 4: Fiberglass Insulation in Return Air Compartment

Due to the age of the equipment and poor condition of components, replacement of existing equipment should be considered. A HVAC upgrade should include installation of air supply and return ductwork to rooms in the high school. The current method of air distribution through below-grade tunnels should be discontinued. Since a HVAC upgrade will require an extended period of time to complete, the following recommendations are provided to help improve indoor air quality in the short-term:

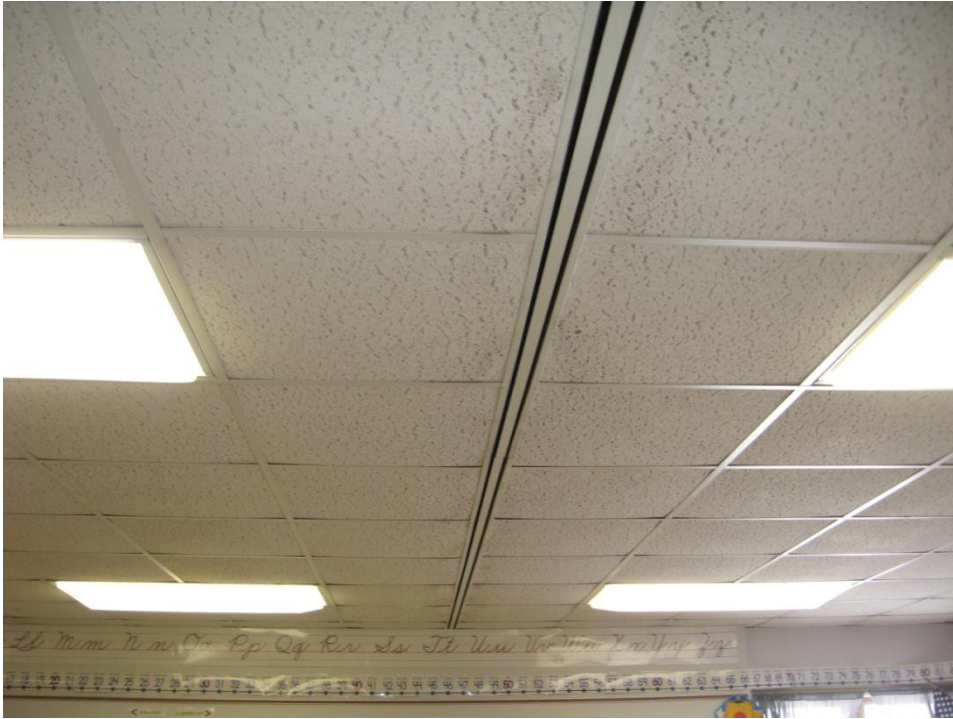
Based on our observations, air supplied to classrooms may not mix properly due to type and location of the air supply diffuser. A single linear air supply diffuser is installed across the middle of the rooms (see *Photo 5*). Air return is located in the hallways. In our opinion, this arrangement will not provide proper mixing of room air, which may contribute to the higher than recommended carbon dioxide levels.

Photo 5: Single Linear Air Supply Diffuser in Elementary Classrooms

An engineering study of the ventilation system should be performed to determine if air supply and returns to each room should be modified to provide better ventilation effectiveness. The study should also include an evaluation of system operation and temperature control.

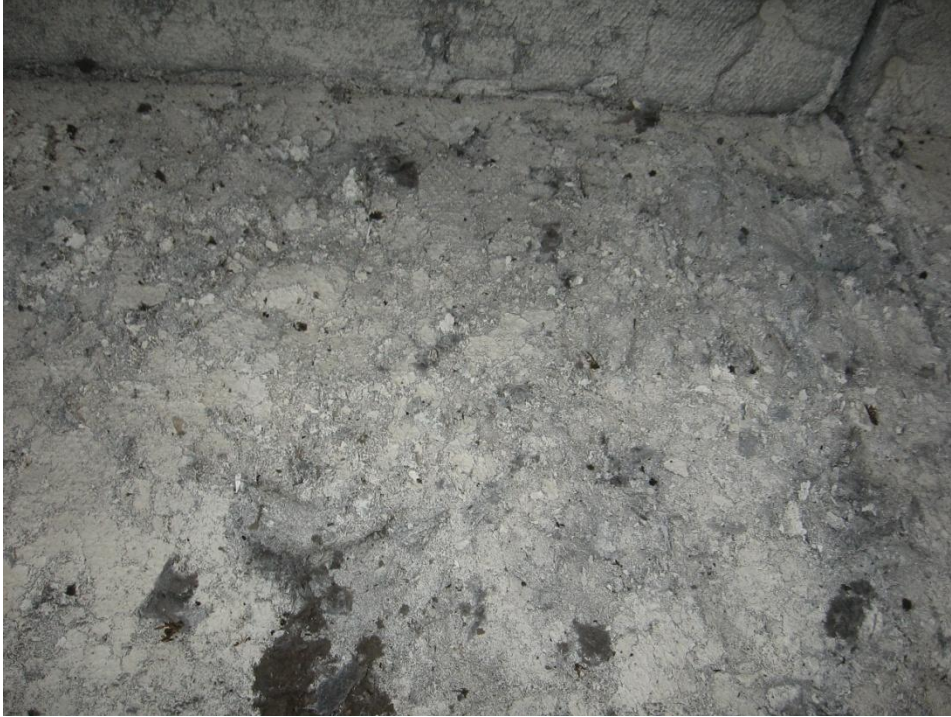
The internal fiberglass insulation in the AHU was in poor condition (appeared worn). According to information provided, the system had been cleaned and the insulation coated with a white paint-like material (see *Photo 6*).

Photo 6: Worn Fiberglass Insulation inside Mixed Air Compartment of AHU

Remove all fiberglass insulation that is located in the AHU and associated ductwork, and perform extensive cleaning of the entire HVAC system. If insulation replacement is required, use close cell foam insulation instead of fiberglass.
